Assessment of Paint Layers by FE-SEM and EDS Examination

ARL-TR-3232

June 2004

Weapons and Materials Research Directorate, ARL

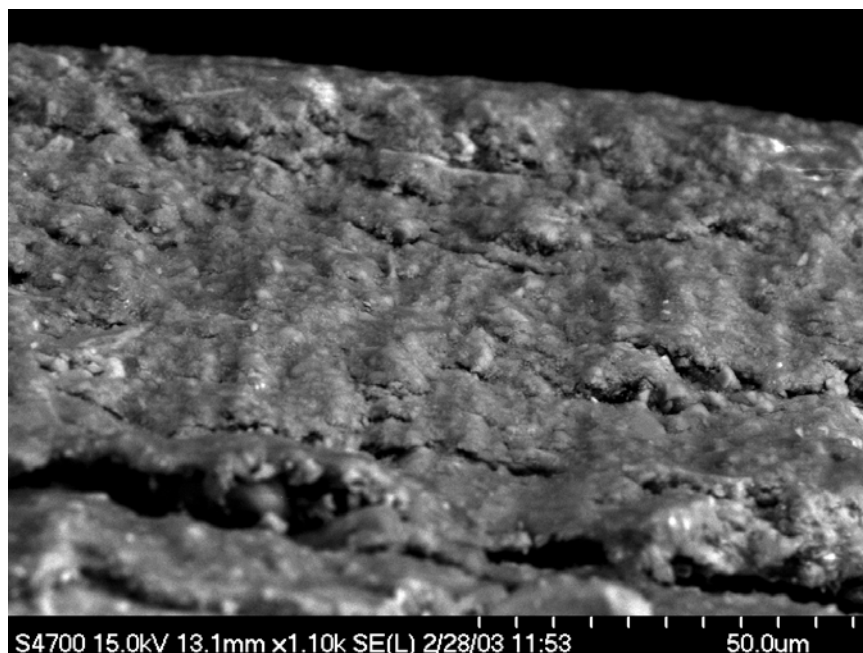
Figures 6 and 7 complete the available morphology documentation from panel 7. Note in figure 7 that only a portion of the surface is in clear focus. The film edge being imaged is below the panel fracture edge, and the size of both the vise mount and the panel strip limited stage tilt, so it was not possible to clearly focus the entire depth or width of the film thickness.

Figure 7. Lower SE detector image of panel 7 coating with aluminum panel (foreground).

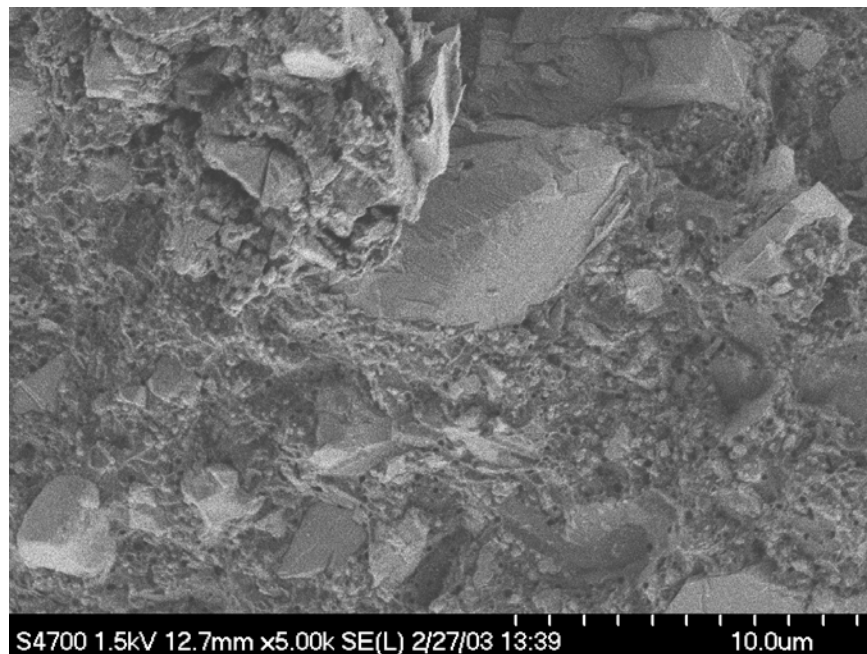
At 5 KX, the lower SE detector has a reduced resolution (figure 10), while the YAGBSE (figure 11) provides a clearer image even with charging present.

Figure 10. Lower SE detector image of film from panel 2.

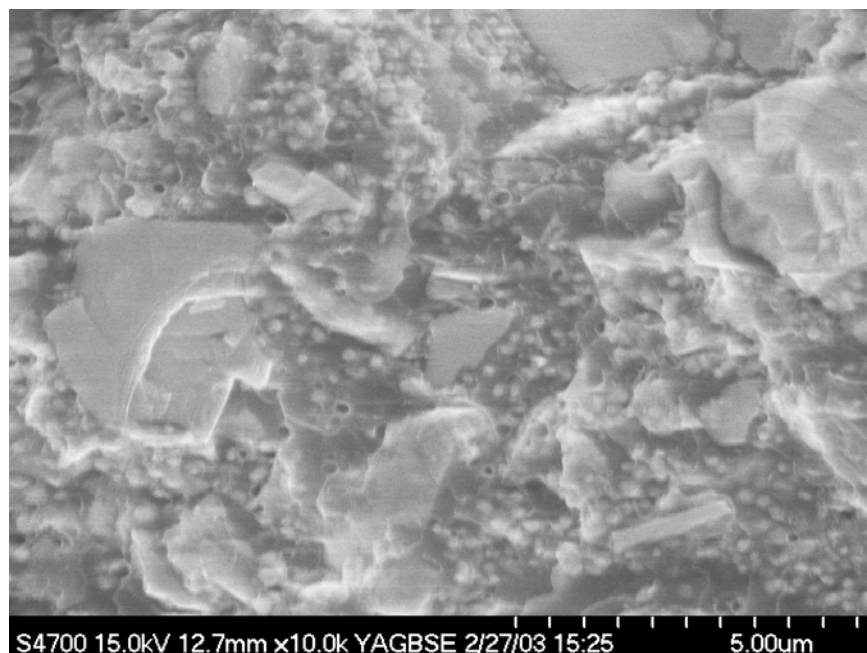
Figure 11. YAGBSE image of film from panel 2.

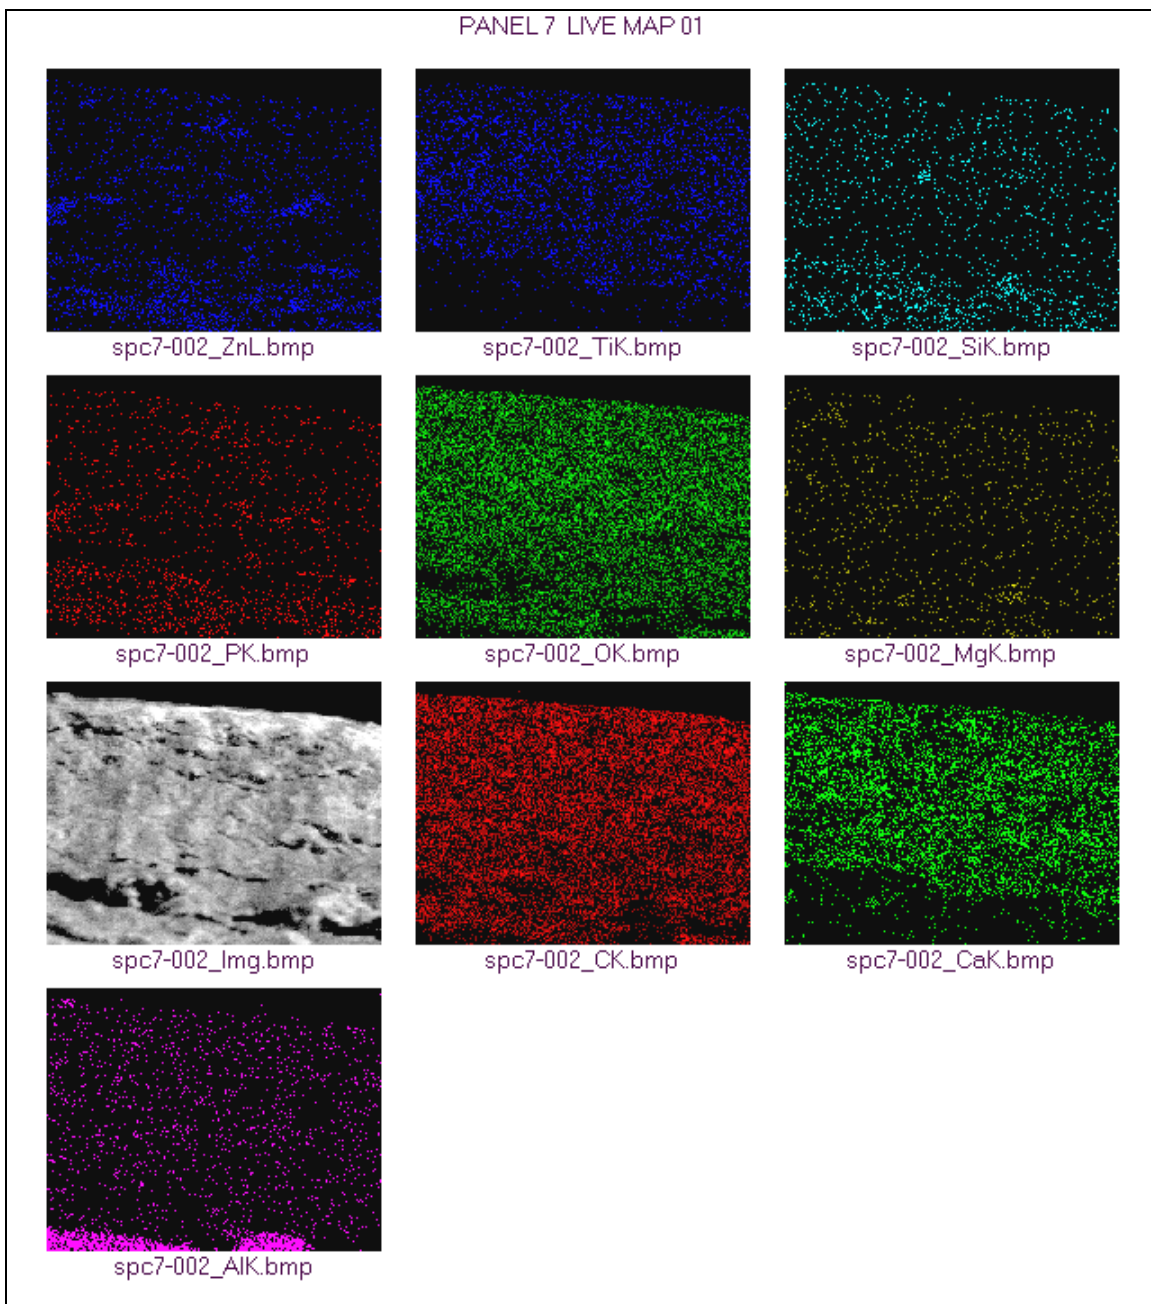
Then a Live elemental map was captured at 500-ms dwell time/frame of 256×200 pixels. The spectrum and mapping were performed at 15-KeV and 10- μ A emission current. The elemental maps were allowed to build so that titanium distributions were readily evident. Figure 19, Live map 01, is at 1.5 KX, and figure 20, Live map 03, at 2 KX. Comparing the two Al K maps shows an alignment error between the S-4700 and the EDAX external control module. Note the total absence of a chromium response. Because of the sample handling problems and the failure to see any changes in distribution with the panel 7 sample, it was decided to work with the free film from panel 5.

Figure 19. Live map of panel 7 film at 15 KeV and 1.5 KX.

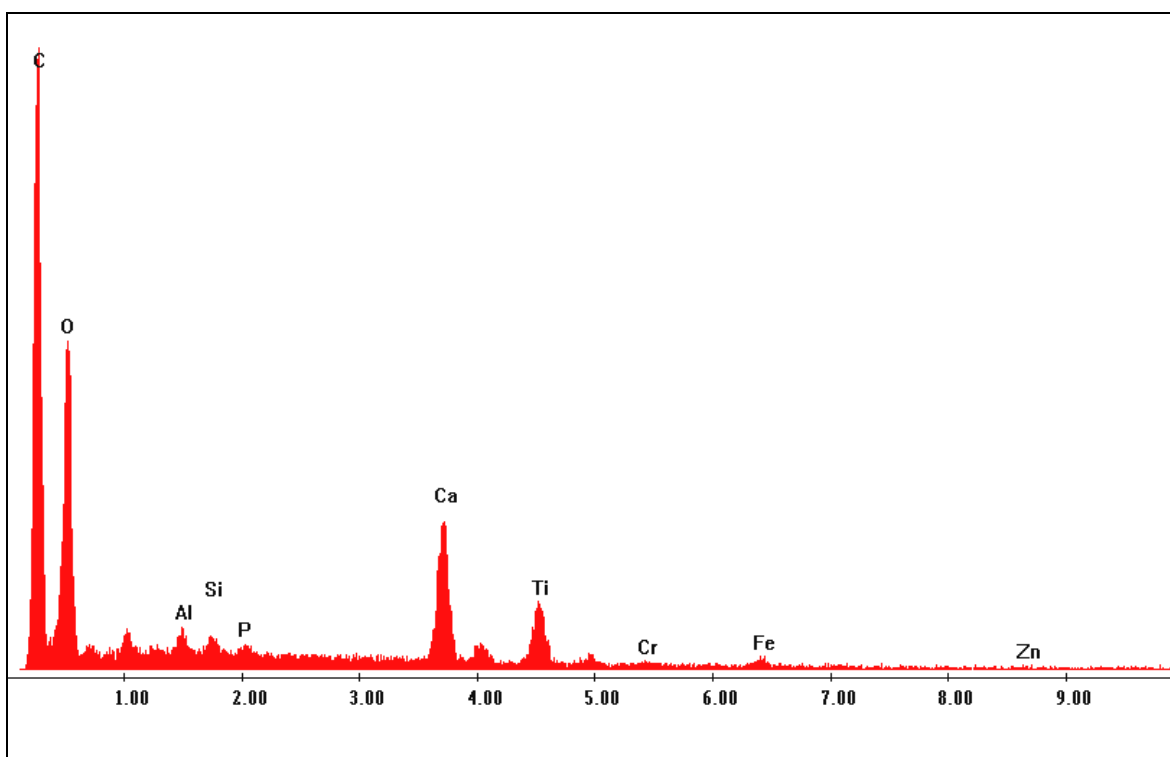
Figure 23. Panel 5 free-film spectrum using Hitachi Live image for alignment.

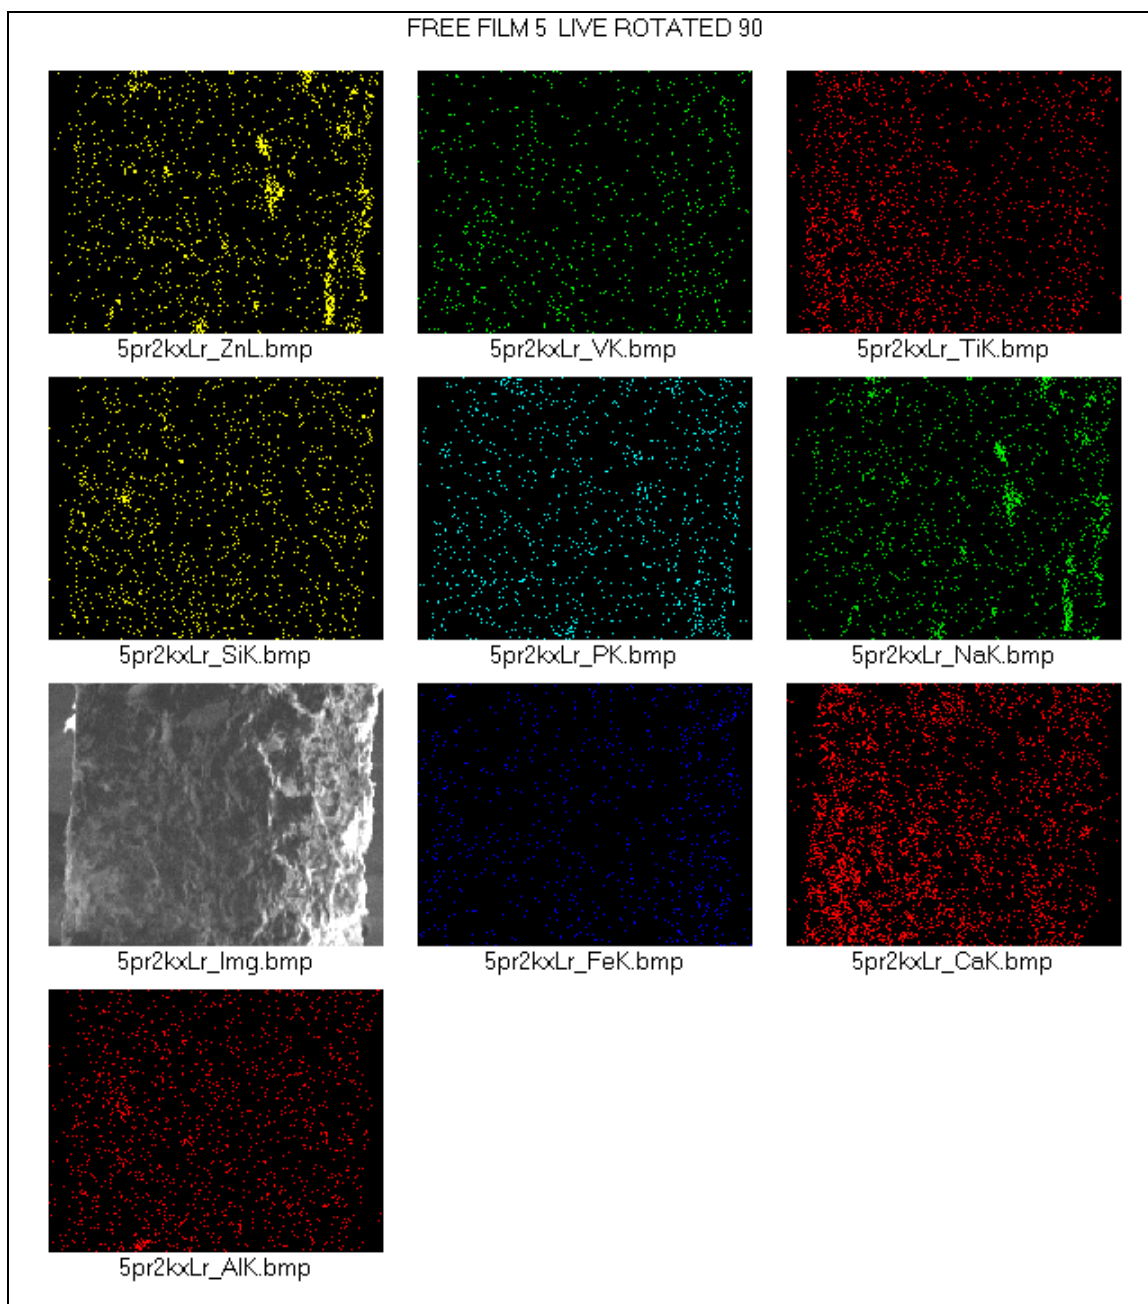
A Live mapping of this same region is shown in figure 25. For the Live mapping the dwell time was 100 ms/256 × 200 pixels frame, and 32 frames were captured. Note the loss of response for the P K peak.

Figure 25. Live mapping of figure 24 region post Quant mapping.

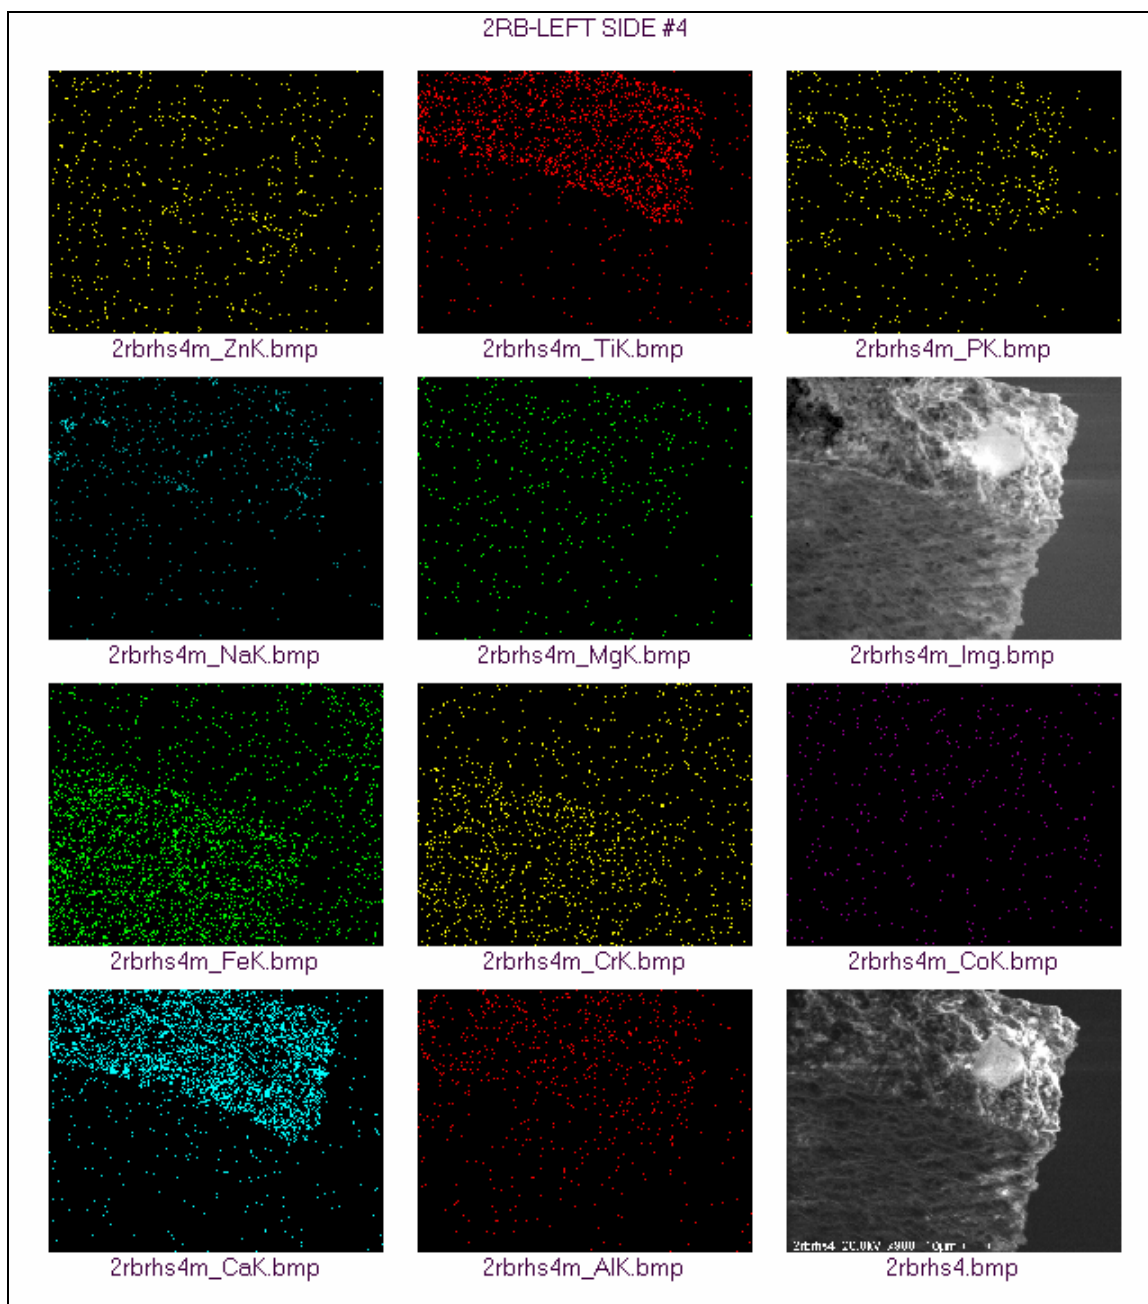
The Cr K maps in figures 29 and 30 appear to be similar for each edge. This may be a result of stacking the panels coated face to chromated face. These Live maps don't have sufficient information to identify a panel interface surface (figure 31).

Figure 31. Repeat of Live elemental map from figure 29.
